**LVDL Outdoor Space Plan**

50% Master Plan | November 14, 2022

**OVERALL SITE ANALYSIS**

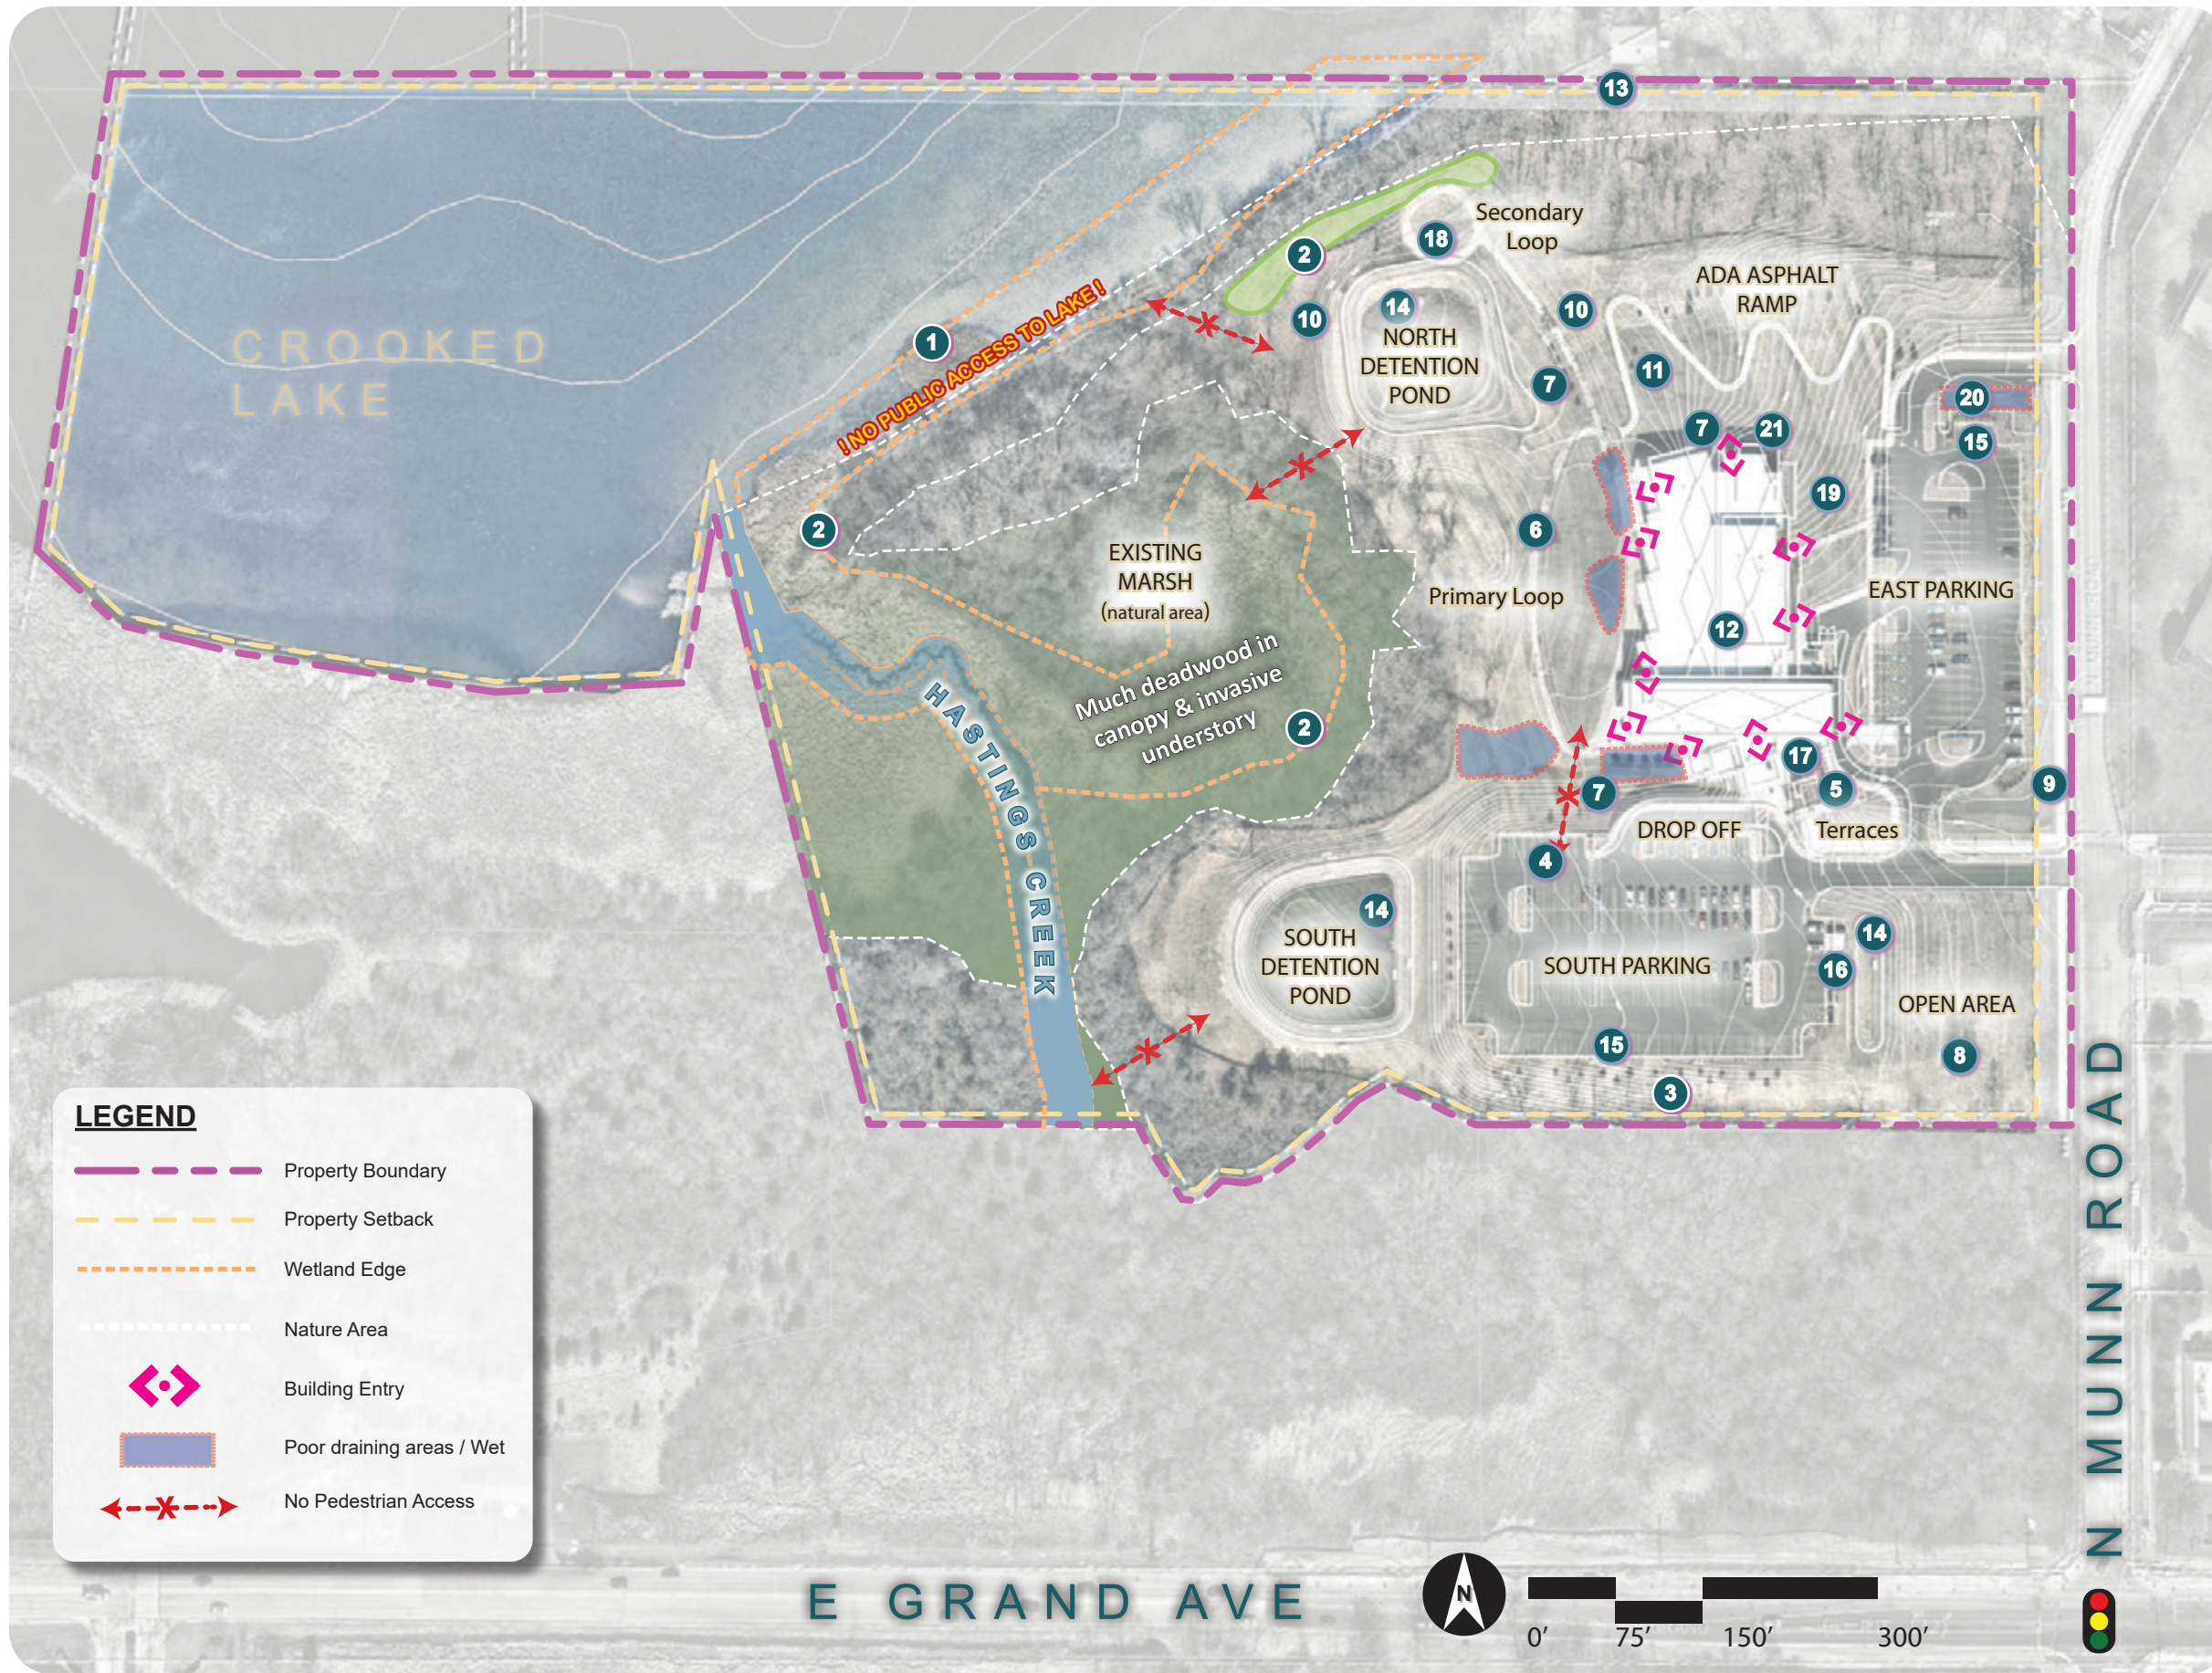
- 1 Crooked Lake is a private lake managed by an association. There is no public access.
- 2 Evidence of natives in remnant sedge meadow. Native woodland species observed to be peaking out. Buckthorn has taken over areas.

- 3 Consider screening property edge against future development of adjacent property.
- 4 Create access to lower area from the south parking lot.
- 5 Terraces become hot spots during the afternoon. Shade is much needed in this area so the outdoor spaces can be used by patrons and employees.

- 6 Gravel path is holding up but edge is creating several tripping hazards. Furnishings are too close to the walk. The path is too narrow.
- 7 Large plants placed in locations that block views to the lake, and adjacent spaces

- 8 Unused open space that would benefit from flexible programming
- 9 Potential for bike connectivity to support local & regional improvement plans and bike integration.

- 10 Shelter like areas needed to provide shade, reading, rest, and meditation.
- 11 Storm water inlets set too high to function.
- 12 Take advantage of and enhance views from inside the building and terraces.

- 13 Screen adjacent neighbors.
- 14 Detention ponds /rain gardens have poorly established native seed with invasive species taking over into the landscape buffer. There is some concern over long term function of underdrains for volume below outlet elevation.

- 15 Snow piling / staging area during winter months.
- 16 Relocated dumpster
- 17 Sculpture creates a quiet space & focal point but lacks planting to support the space.

- 18 Under utilized path that leads to a dead end. Signs of deer ruts on trunks.
- 19 Roof drain outfall in turf
- 20 Wet area with failing plants
- 21 Steep slopes adjacent to building
